**Flood Control Project Maintenance  
Levee Inspections**  
**LMA District Cover Sheet**  
**Spring 2020 Levee Inspection Results**

**Reclamation District No. 0017 Mossdale**

**Levee Inspection Report By Mile - Spring 2020**

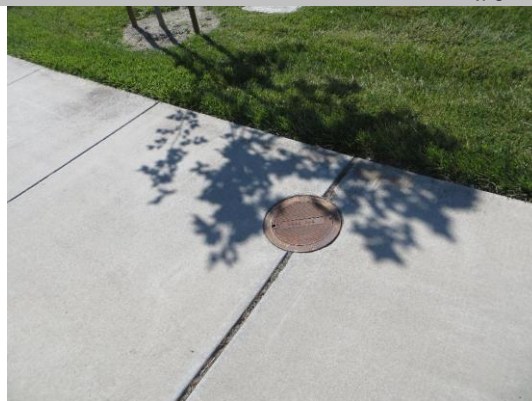
Photo 1 of 3 : UCIP\_SP\_2020\_49990\_74222.jpg

DS\_ID:72  
 FS\_ID:49990  
 EP\_NO: 15185  
 Repair Type: Non-Urgent  
 Crossing Status: Indicator Found  
 UCIP Comments: 04/06/2018 Received supporting information from T. Marlow with KSN pertaining to line. PG&E has installed gas line distribution markers on both shoulder of the levee. Crossing is an active line. PG&E performs a leak survey at least twice a year according to Mr. R. Muok, Supervisor, Gas Pipeline Operations and Maintenance Stockton. Mr. Muok can be reached at 209-406-7926. Crossing has been downgraded from Urgent to Non-Urgent--pipe is inspected by owner. UCIP will need to coordinate with PG&E to obtain confirmation of inspections, obtain emergency contact information, and maintenance contact information. (DWR UCIP - O. Magana)  
 07/12/2016 No markers (no photos taken in 2016). Need to contact owner to determine status of crossing. If crossing is active, owner will need to coordinate with CVFPB to install markers to comply with Title 23. (DWR UCIP - omagana)5/19/2015 Need to install gasline markers. (DWR UCIP - omagana)

Gas access lid in sidewalk Approximately 200-feet to west of crown.

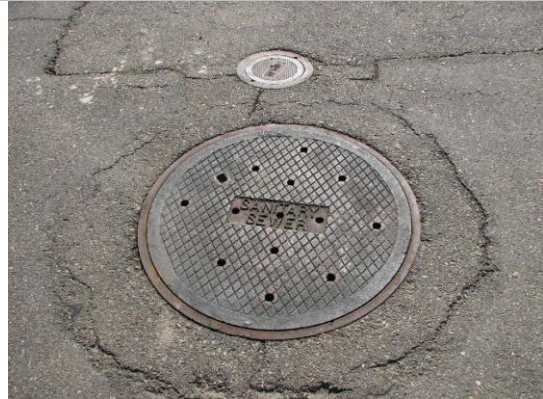
Photo 3 of 3 : UCIP\_SP\_2020\_40604\_38495.jpg

Manhole found on landward side.

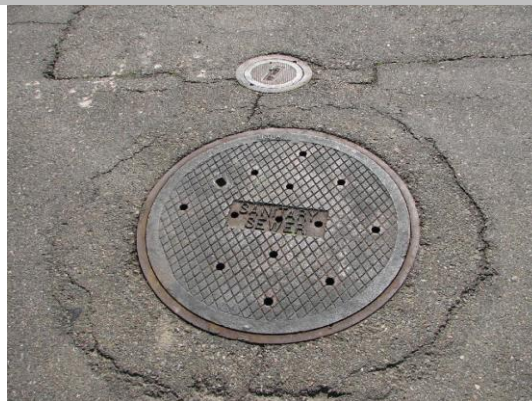
Photo 3 of 3 : UCIP\_SP\_2020\_40606\_71940.jpg

Manhole visible on landward side.

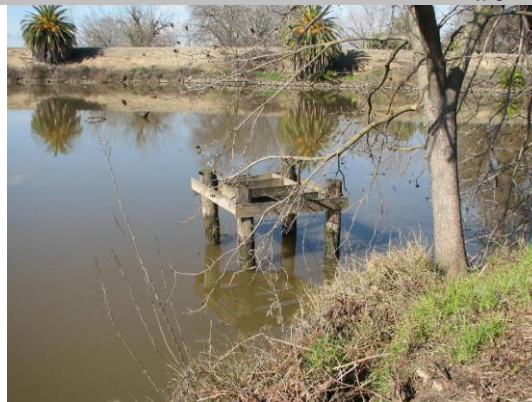
Photo 2 of 3 : UCIP\_SP\_2020\_40628\_38515.jpg

Comment Code						
Inspector Comment						
DS_ID:75 FS_ID:40628 EP_NO: 15093 Repair Type: Non-Urgent Crossing Status: Found UCIP Comments: Only appurtenances remaining at this location--4 pillings located on waterward side. According to records the pillings were to be removed under a completion maintenace contract. Need to coordinate with owner. FIELD_STRUCT_DESC: 14-inch-diameter pipeline through levee at unknown depth. Per inspector's notes "this crossing is abandoned almost all materials removed including pipes, conduit, and pump house. The only items left are 4 pilings which are to be removed under a completion maintenance contract. Approximately 200 feet of reinforced concrete pipe lateral removed in R/W south of crossing". FS Date: 2/3/2010

View of waterward side--pillings inside channel.

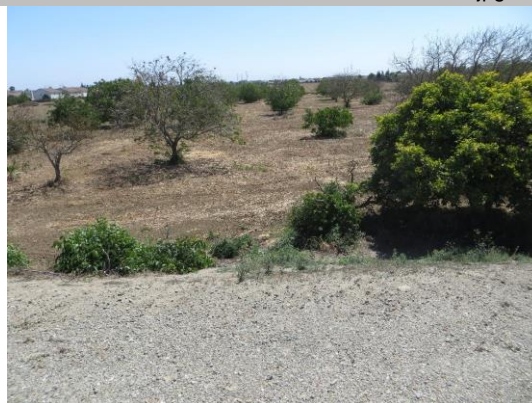
Photo 2 of 2 : UCIP\_SP\_2020\_45449\_74104.jpg

No markers on LS.

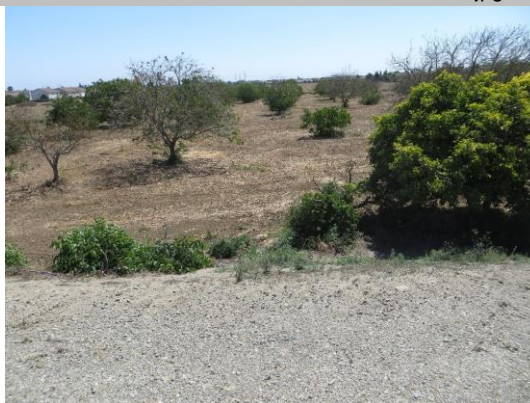
Photo 2 of 2 : UCIP\_SP\_2020\_45450\_74106.jpg

No markers on LS.

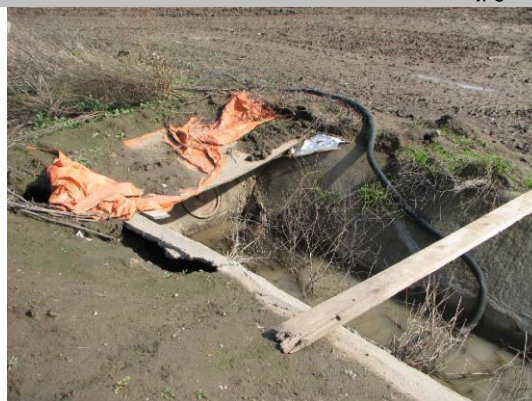
Photo 3 of 3 : UCIP\_SP\_2020\_40640\_71983.jpg

Concrete irrigation canal located at landward toe just upstream of crossing.

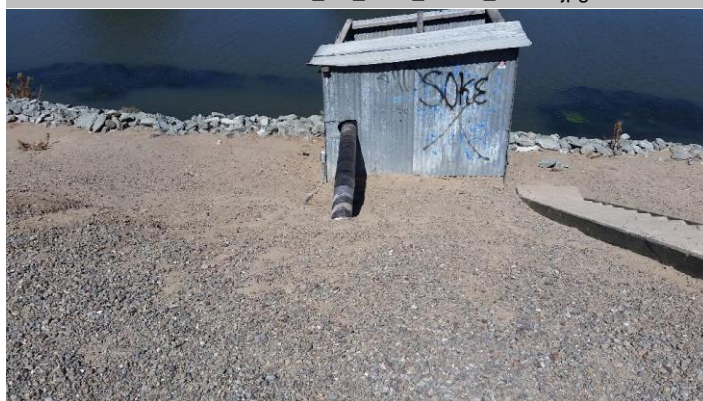
Photo 1 of 3 : UCIP\_SP\_2020\_53328\_75745.jpg

View of WS--slope cleared of vegetation.

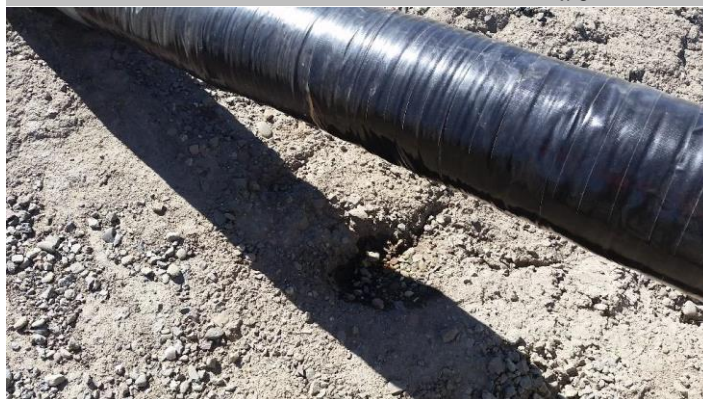
Photo 2 of 3 : UCIP\_SP\_2020\_53328\_75742.jpg

WS view--moisture observed on ground below wrapped pipe section,  
photo 1 of 2.

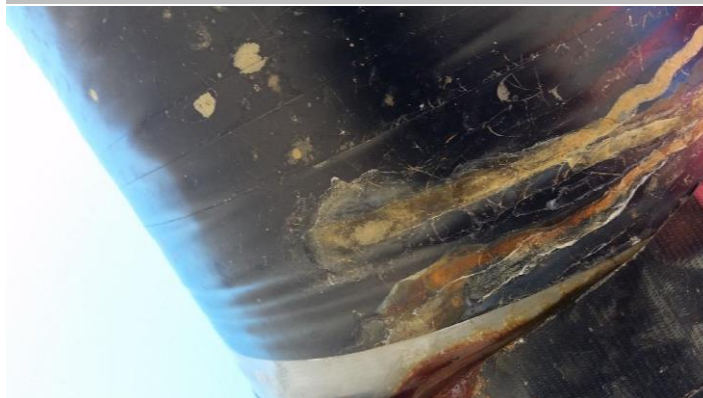
Photo 3 of 3 : UCIP\_SP\_2020\_53328\_75743.jpg

Pipe leak visible on WS pipe section, photo 2 of 2.

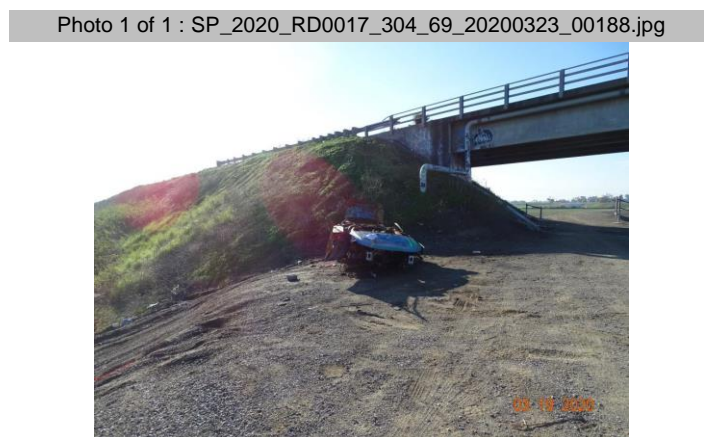
LM Start	2.87	Rating **	M	Issue No.	69
LM End	2.87	Issue Type +	Ma	Location *	LS
Category	Earthen Levee			GPS Latitude/Longitude	
				Start	End
Item	Encroachments			37.878043 °	37.878043 °
				-121.331606 °	-121.331606 °
DWR ID	DWR_RD0017_02_s_2020_69				
Comment Code					
AV : Abandoned vehicles					
Inspector Comment

View of an abandoned vehicle on landside shoulder. Spring 2020

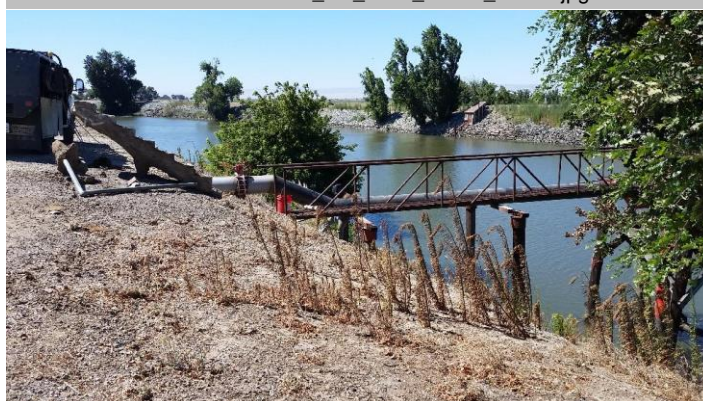
Photo 2 of 3 : UCIP\_SP\_2020\_50004\_75871.jpg

View of WS--coated pipe, walkway, and removal of concrete stairway.  
Construction in progress.

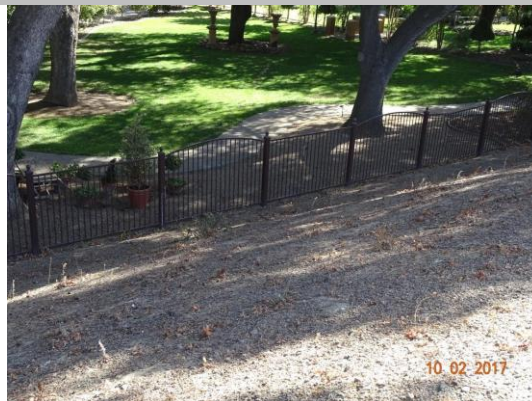
Photo 1 of 1 : SP\_2020\_RD0017\_304\_79\_20200228\_00003.jpg

View of metal fence within flood control right of way on landside slope.

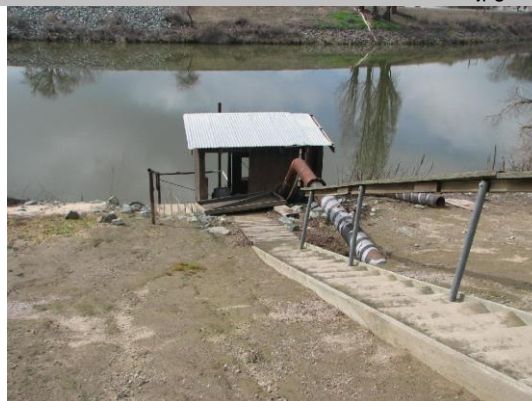
Photo 2 of 3 : UCIP\_SP\_2020\_40662\_72128.jpg

View of waterward side--pump house, walkway, pipe, and abandoned pipe section.

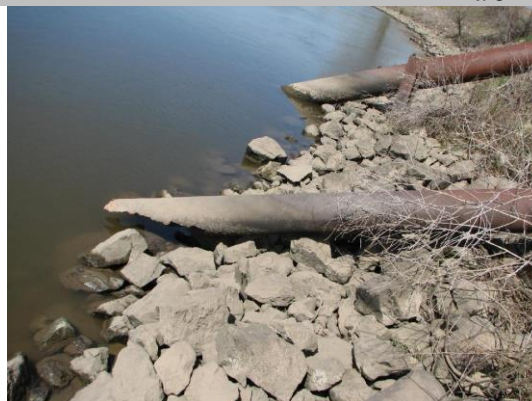
Photo 3 of 3 : UCIP\_SP\_2020\_40672\_72271.jpg

Pipe section inside wall has completely corroded--wall missing.

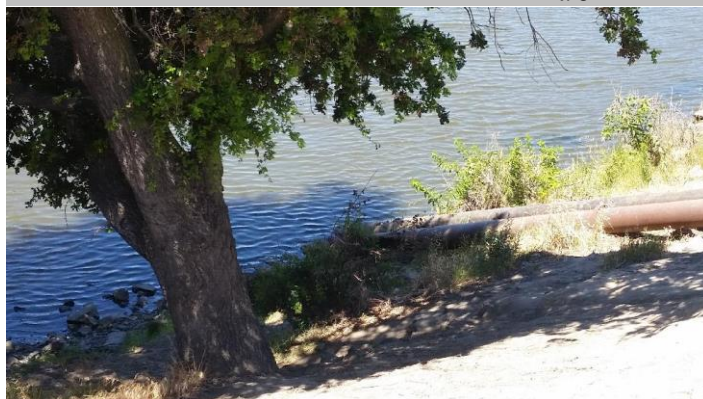
Photo 2 of 3 : UCIP\_SP\_2020\_53331\_75740.jpg

WS-pipe still damage, pipe wall section missing.

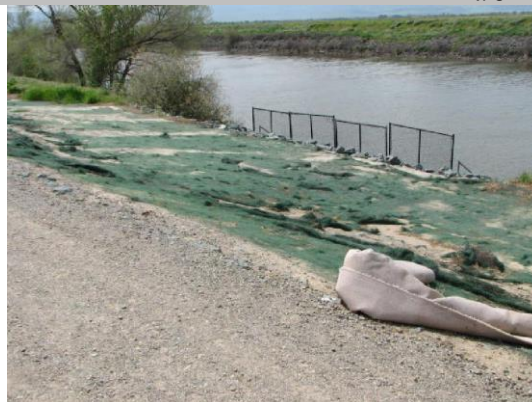
Photo 2 of 3 : UCIP\_SP\_2020\_40696\_72448.jpg

View of waterward side geotech fabric damage along slope.

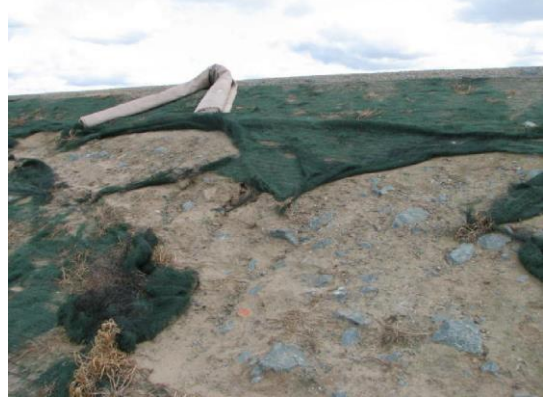
Photo 2 of 3 : UCIP\_SP\_2020\_40697\_72453.jpg

Geotech fabric damage along waterward berm.

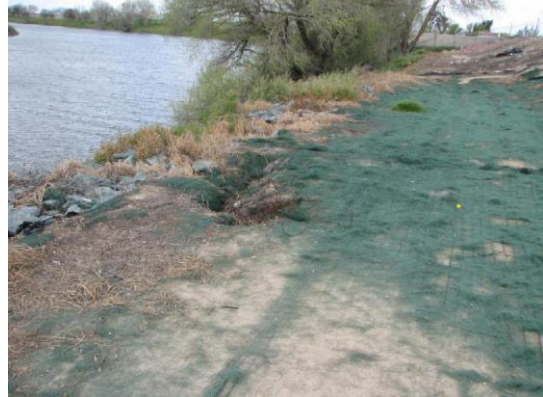
Photo 3 of 3 : UCIP\_SP\_2020\_40697\_72450.jpg

Surface erosion visible on waterward berm edge.

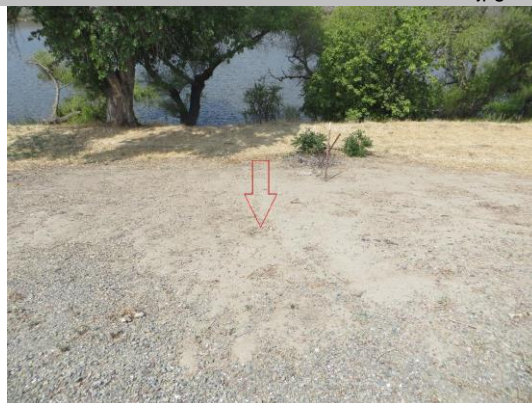
Photo 2 of 3 : UCIP\_SP\_2020\_45463\_74121.jpg

Vent visible on WS slope. Found partially burried.

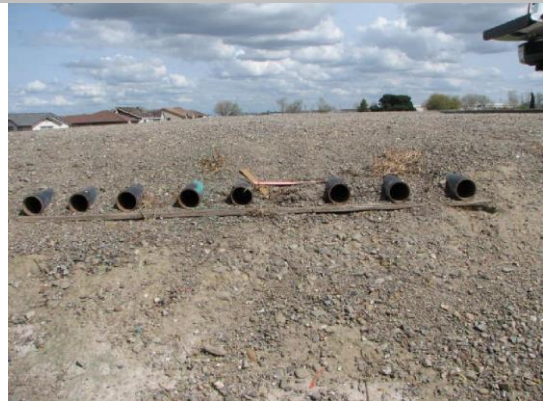
Photo 3 of 3 : UCIP\_SP\_2020\_45993\_72498.jpg

8-4 inch steel coated schedule 40 pipes with about 6 inch of cover.

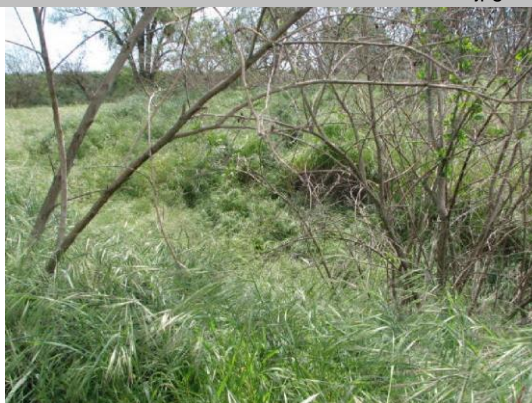
Photo 3 of 3 : UCIP\_SP\_2020\_40716\_72555.jpg

Scour hole located immediately upstream from crossing.
